**Flood Control Project Maintenance
Levee Inspections**

Maintenance Issue Types Only, Levee Inspection Report By Mile - Spring 2018

Reclamation District No. 2101 Blewett

Waterway	Bank	Unit Miles	Inspection Start/End	Inspector
Unit No. 01 San Joaquin River	Left	3.16	03/08/2018 03/08/2018	Maksim Khashchuk

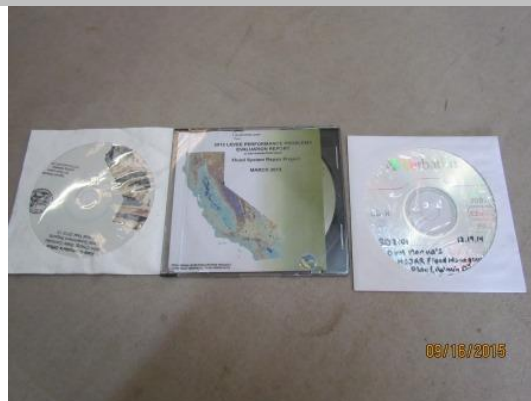
Photo 1 of 1 : SP_2018_RD2101_326_2_20180305_00003.jpg

LM Start		Rating **	A	Issue No.	2		
LM End		Issue Type +	Ma	Location *	N/A		
Category	Earthen Levee			GPS Latitude/Longitude			
				Start		End	
Item	Operations & Maintenance Manuals				o		o
					o		o
DWR ID	DWR_RD2101_01_s_2013_2						
Comment Code							
Inspector Comment							
The LMA has the O&M Manual available electronically.

View of the O&M manual and other documentation.

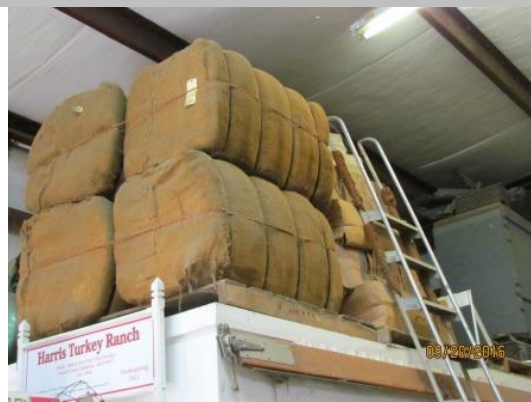
Photo 1 of 2 : SP_2018_RD2101_326_4_20180305_00004.jpg

LM Start		Rating **	A	Issue No.	4		
LM End		Issue Type +	Ma	Location *	N/A		
Category	Earthen Levee			GPS Latitude/Longitude			
				Start		End	
Item	Emergency Supplies & Equipment				o		o
					o		o
DWR ID	DWR_RD2101_01_s_2013_4						
Comment Code							
Inspector Comment							
LMA has emergency supplies on site at the warehouse.

View of the emergency flood fight supplies in the shop.

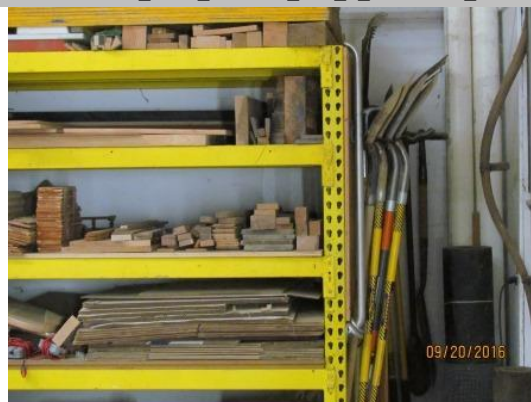
Photo 2 of 2 : SP_2018_RD2101_326_4_20180305_00005.jpg

Another view of the emergency flood fight supplies in the shop.

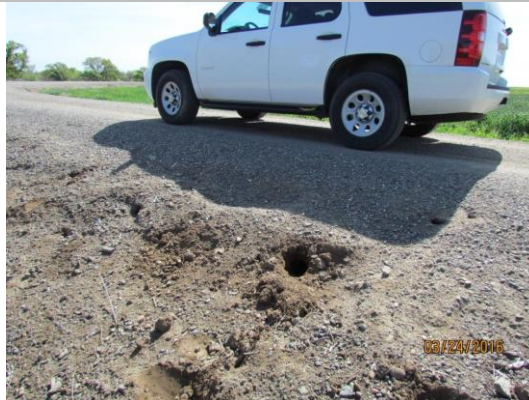
Photo 1 of 1 : SP_2018_RD2101_326_12_20180305_00007.jpg

LM Start	0.04	Rating **	M	Issue No.	12
LM End	0.04	Issue Type +	Ma	Location *	WS
Category	Earthen Levee			GPS Latitude/Longitude	
				Start	End
Item	Animal Control			37.657648 °	37.657648 °
				-121.253812 °	-121.253812 °
DWR ID	DWR_RD2101_01_s_2012_12				
Comment Code					
A3 : No rodents visible, but rodent burrows visible; need to backfill and compact or grout burrows.					
Inspector Comment					
LMA is actively exterminating rodents in this area.

View of the rodent holes on the waterside levee slope, facing upstream.

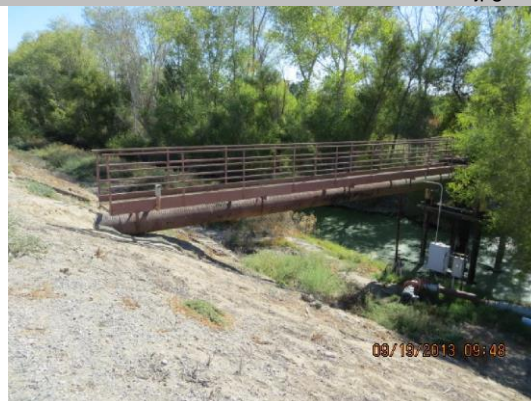
Photo 1 of 3 : UCIP_SP_2018_20752_34980.jpg

LM Start	0.20	Rating **	A/W	Issue No.	946
LM End	0.20	Issue Type +	Ma	Location *	
Category	Supplemental			GPS Latitude/Longitude	
				Start	End
Item	DWR UCIP LMA Responsibility			37.657130 °	37.657130 °
				-121.251695 °	-121.251695 °
DWR ID					
Comment Code					
Inspector Comment					
FS_ID:20752					
DS_ID:20700					
EP_NO: N/A					
Repair Type: No Action Needed					
Crossing Status: Found					
UCIP Comments:					
FIELD_STRUCT_DESC: 20-inch steel drainage pipe through the levee, 2 feet below the crown. Concrete U-shaped headwall and flap gate on the waterside (WS) end. Pump on pile structure on the landside (LS). [Additional Reference(s): DWR Levee Log, 1992. USACE San Joaquin O&M Manual 12, December 1968, (HLM 0.20), 18-inch pipe listed].					
FS Date: 9/19/2013

Pump on platform at LS.

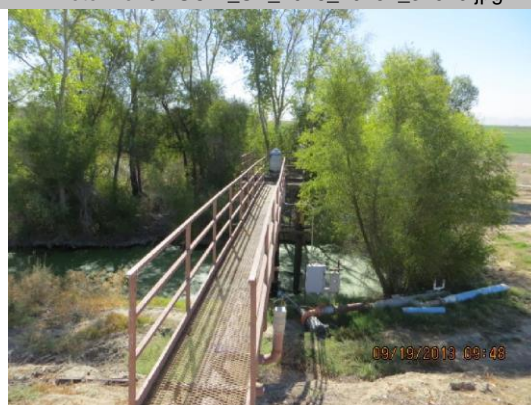
Photo 2 of 3 : UCIP_SP_2018_20752_34979.jpg

Pump on platform at LS.

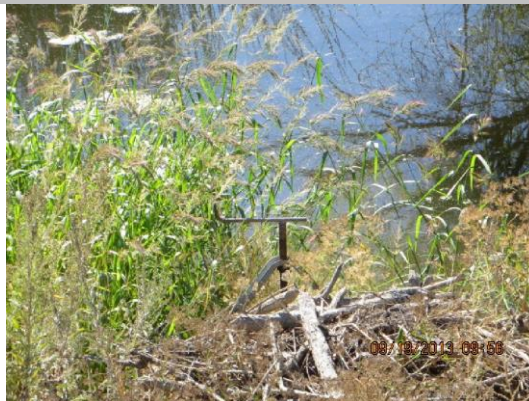
Photo 2 of 3 : UCIP_SP_2018_20785_35045.jpg

LM Start	0.31	Rating **	M	Issue No.	947 (cont)	
LM End	0.31	Issue Type +	Ma	Location *		
Category	Supplemental			GPS Latitude/Longitude		
				Start	End	
Item	DWR UCIP LMA Responsibility			37.658142 °	37.658142 °	
				-121.250047 °	-121.250047 °	
DWR ID						
Comment Code						
Inspector Comment						
FS_ID:20785 DS_ID:20701 EP_NO: N/A Repair Type: Non-Urgent Crossing Status: Found UCIP Comments: Inlet blocked by soil from beaver activity. Outlet covered in soil. FIELD_STRUCT_DESC: 24-inch corrugated metal drainage pipe through the levee, 21 feet below the crown. Headwall and slide gate on the landside (LS) end. Concrete U-shaped headwall and flap gate on the waterside (WS) end. [Additional Reference(s): DWR Levee Log, 1992. USACE San Joaquin O&M Manual 12, December 1968, (HLM 0.31)]. FS Date: 9/19/2013

Slide gate at concrete headwall on LS toe.

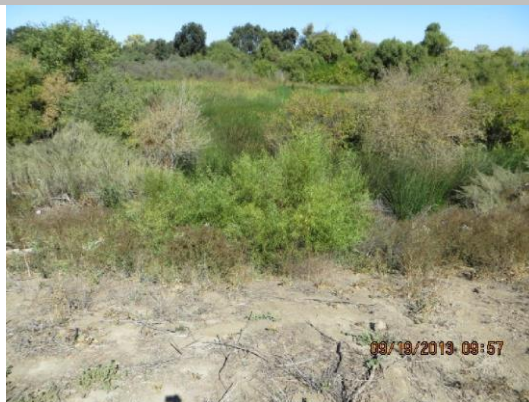
Photo 3 of 3 : UCIP_SP_2018_20785_35044.jpg

Outlet covered in soil but likely at willow tree on WS slope.

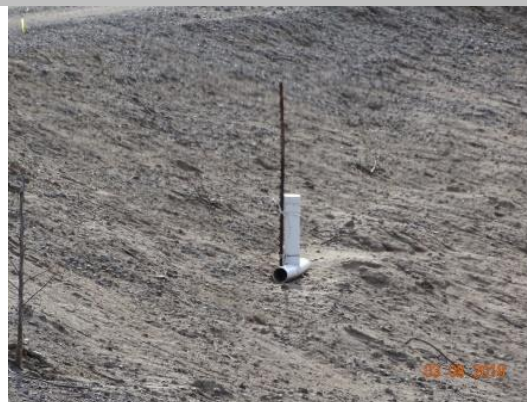
Photo 1 of 1 : SP_2018_RD2101_326_19_20180308_00055.jpg

LM Start	0.82	Rating **	M	Issue No.	19
LM End	0.82	Issue Type +	Ma	Location *	WS
Category	Earthen Levee		GPS Latitude/Longitude		
			Start	End	
Item	Animal Control		37.658918 °	37.658918 °	
			-121.242544 °	-121.242544 °	
DWR ID	DWR_RD2101_01_s_2017_19				
Comment Code					
A3 : No rodents visible, but rodent burrows visible; need to backfill and compact or grout burrows.					
Inspector Comment					
LMA installed bait stations to exterminate rodents. Backfill and compact rodent hole.

View of the bait station on the levee slope.

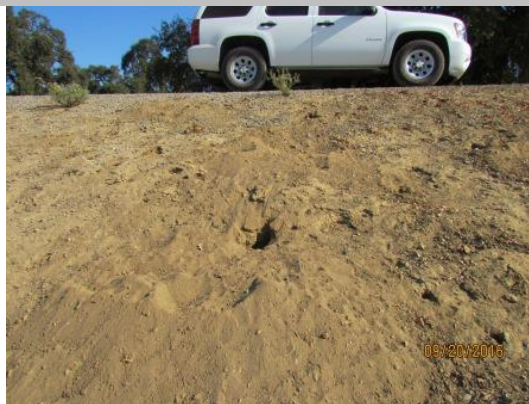
Photo 1 of 1 : SP_2018_RD2101_326_21_20180305_00010.jpg

LM Start	0.86	Rating **	M	Issue No.	21
LM End	0.86	Issue Type +	Ma	Location *	LS
Category	Earthen Levee			GPS Latitude/Longitude	
				Start	End
Item	Animal Control			37.658715 °	37.658715 °
				-121.241945 °	-121.241945 °
DWR ID	DWR_RD2101_01_f_2016_21				
Comment Code					
A1 : Exterminate rodents and backfill and compact or grout burrows.					
Inspector Comment

View of the rodent hole on the landside slope.

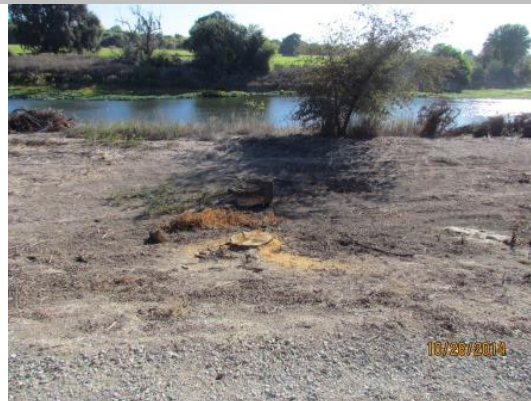
Photo 1 of 1 : SP_2018_RD2101_326_33_20180305_00019.jpg

LM Start	1.02	Rating **	N	Issue No.	33
LM End	1.02	Issue Type +	Ma	Location *	WS
Category	Earthen Levee			GPS Latitude/Longitude	
				Start	End
Item	Trim / Thin Trees			37.656745 °	37.656745 °
				-121.241104 °	-121.241104 °
DWR ID	DWR_RD2101_01_f_2014_33				
Comment Code					
T5 : Tree stumps.					
Inspector Comment

View of the tree stump at the waterside levee toe.

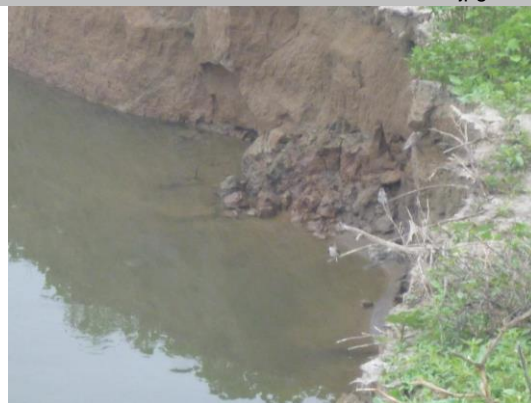
Photo 3 of 3 : LEVAL_SP_2018_133_228.jpg

LM Start	1.87	Rating **	A/W	Issue No.	39 (cont)
LM End	1.96	Issue Type +	Ma	Location *	
Category	Supplemental			GPS Latitude/Longitude	
				Start	End
Item	2017 Storm Damage			37.650550 °	37.649980 °
				-121.229570 °	-121.228040 °
DWR ID	DWR_RD2101_01_f_2017_39				
Comment Code					
Inspector Comment					
Levee Evaluation Comments					
Description:					
Site ID No:133					
Site Designation:DWR_RD2101_01_s_2012_1					
Repair Type: Erosion					
Rating:Critical					
Field Date:6/8/2017					
Notes: Lineal cracking on the levee crown is visible. Erosion scarp is near vertical. This site was repaired at the time of the Fall 2017 inspection.

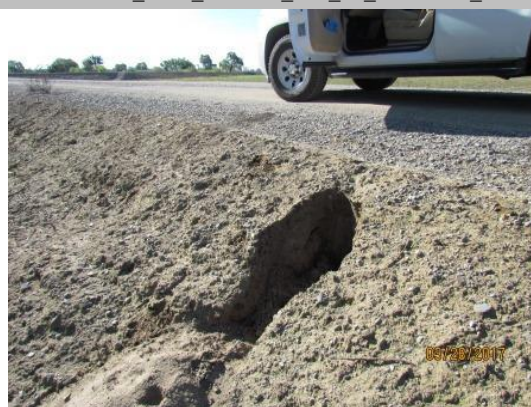
Photo 1 of 1 : SP_2018_RD2101_326_24_20180305_00011.jpg

LM Start	2.23	Rating **	U	Issue No.	24
LM End	2.23	Issue Type +	Ma	Location *	LS
Category	Earthen Levee			GPS Latitude/Longitude	
				Start	End
Item	Animal Control			37.647088 °	37.647088 °
				-121.225077 °	-121.225077 °
DWR ID	DWR_RD2101_01_s_2017_24				
Comment Code					
A1 : Exterminate rodents and backfill and compact or grout burrows.					
Inspector Comment					
LMA installed bait stations throughout the district. Backfill and compact rodent holes.

View of the rodent burrow on the levee slope.

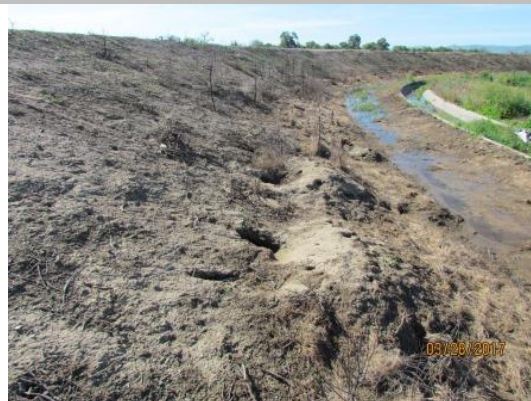
Photo 1 of 1 : SP_2018_RD2101_326_25_20180305_00012.jpg

LM Start	2.46	Rating **	U	Issue No.	25
LM End	2.46	Issue Type +	Ma	Location *	LS
Category	Earthen Levee			GPS Latitude/Longitude	
				Start	End
Item	Animal Control			37.644691 °	37.644691 °
				-121.227681 °	-121.227681 °
DWR ID	DWR_RD2101_01_s_2017_25				
Comment Code					
A1 : Exterminate rodents and backfill and compact or grout burrows.					
Inspector Comment

View of the multiple rodent burrows on the levee slope.

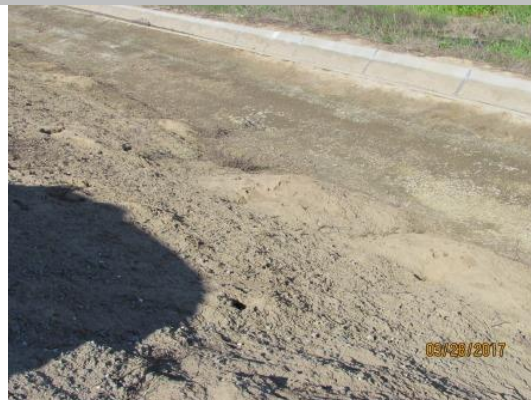
Photo 1 of 1 : SP_2018_RD2101_326_30_20180305_00018.jpg

LM Start	2.52	Rating **	U	Issue No.	30
LM End	2.52	Issue Type +	Ma	Location *	LS
Category	Earthen Levee			GPS Latitude/Longitude	
				Start	End
Item	Animal Control			37.644166 °	37.644166 °
				-121.228386 °	-121.228386 °
DWR ID	DWR_RD2101_01_s_2017_30				
Comment Code					
A1 : Exterminate rodents and backfill and compact or grout burrows.					
Inspector Comment					
Multiple large rodent holes.

View of the rodent burrows on the levee slope near the toe.

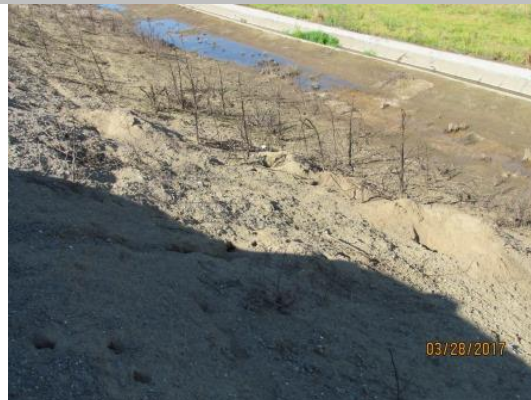
Photo 1 of 1 : SP_2018_RD2101_326_36_20180305_00020.jpg

LM Start	2.56	Rating **	U	Issue No.	36
LM End	2.56	Issue Type +	Ma	Location *	LS
Category	Earthen Levee			GPS Latitude/Longitude	
				Start	End
Item	Animal Control			37.643733 °	37.643733 °
				-121.229083 °	-121.229083 °
DWR ID	DWR_RD2101_01_s_2017_36				
Comment Code					
A1 : Exterminate rodents and backfill and compact or grout burrows.					
Inspector Comment

View of the multiple rodent burrows on the levee slope.

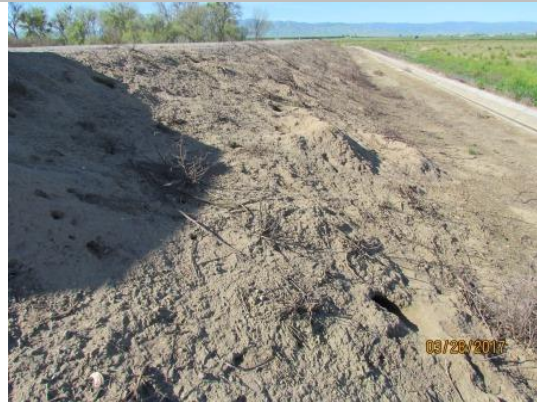
Photo 1 of 1 : SP_2018_RD2101_326_37_20180305_00021.jpg

LM Start	2.67	Rating **	U	Issue No.	37
LM End	2.67	Issue Type +	Ma	Location *	LS
Category	Earthen Levee			GPS Latitude/Longitude	
				Start	End
Item	Animal Control			37.642436 °	37.642436 °
				-121.229854 °	-121.229854 °
DWR ID	DWR_RD2101_01_s_2017_37				
Comment Code					
A1 : Exterminate rodents and backfill and compact or grout burrows.					
Inspector Comment

View of the multiple rodent burrows on the levee slope.

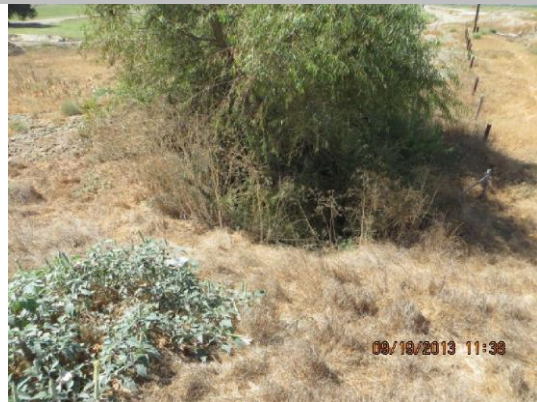
Photo 1 of 3 : UCIP_SP_2018_51392_35142.jpg

LM Start	2.82	Rating **	U	Issue No.	950
LM End	2.82	Issue Type +	Ma	Location *	
Category	Supplemental			GPS Latitude/Longitude	
				Start	End
Item	DWR UCIP LMA Responsibility			37.640566 °	37.640566 °
				-121.230216 °	-121.230216 °
DWR ID

Comment Code					
Inspector Comment					
FS_ID:51392 DS_ID:20705 EP_NO: N/A Repair Type: Urgent Crossing Status: Found UCIP Comments: 11/16/2016 No access available. Need to coordinate with LMA to obtain access for proper inspection at a later date. (O. Magana - DWR UCIP)09/19/2013 Flap gate missing from WS headwall. (W. Wylie - DWR UCIP) FIELD_STRUCT_DESC: 24-inch corrugated metal drainage pipe through the levee, 11 feet below the crown. Concrete U-shaped headwalls on both ends. Flap gate on the waterside (WS) end. [Additional Reference(s): DWR Levee Log, 1992. USACE San Joaquin O&M Manual 12, December 1968, (HLM 2.85), Drawing No. 07-04-1666, Sheets 1666/13 and 1666/51, (Station 421+30)]. FS Date: 11/16/2016

Concrete headwall visible at LS toe in ditch.

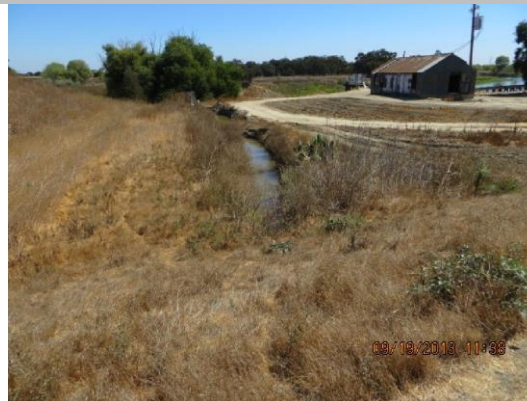
Photo 2 of 3 : UCIP_SP_2018_51392_35141.jpg

Comment Code						
Inspector Comment						
FS_ID:51392 DS_ID:20705 EP_NO: N/A Repair Type: Urgent Crossing Status: Found UCIP Comments: 11/16/2016 No access available. Need to coordinate with LMA to obtain access for proper inspection at a later date. (O. Magana - DWR UCIP)09/19/2013 Flap gate missing from WS headwall. (W. Wylie - DWR UCIP) FIELD_STRUCT_DESC: 24-inch corrugated metal drainage pipe through the levee, 11 feet below the crown. Concrete U-shaped headwalls on both ends. Flap gate on the waterside (WS) end. [Additional Reference(s): DWR Levee Log, 1992. USACE San Joaquin O&M Manual 12, December 1968, (HLM 2.85), Drawing No. 07-04-1666, Sheets 1666/13 and 1666/51, (Station 421+30)]. FS Date: 11/16/2016

Concrete headwall visible on WS toe at canal.

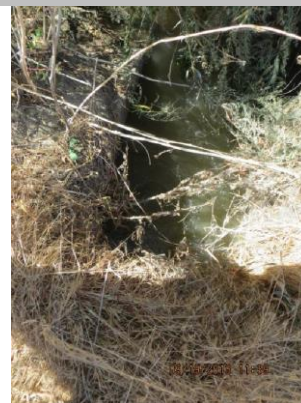
Photo 3 of 3 : UCIP_SP_2018_51392_35140.jpg

Concrete headwall at LS toe.

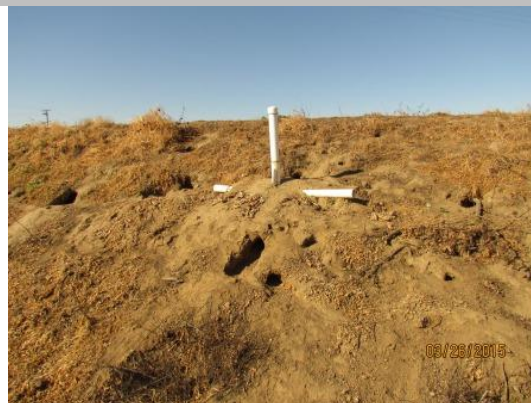
Photo 1 of 1 : SP_2018_RD2101_326_27_20180305_00014.jpg

LM Start	2.83	Rating **	U	Issue No.	27
LM End	2.83	Issue Type +	Ma	Location *	WS
Category	Earthen Levee			GPS Latitude/Longitude	
				Start	End
Item	Animal Control			37.640425 °	37.640425 °
				-121.230139 °	-121.230139 °
DWR ID	DWR_RD2101_01_s_2012_27				
Comment Code					
A3 : No rodents visible, but rodent burrows visible; need to backfill and compact or grout burrows.					
Inspector Comment					
Burrows on both sides of levee. Backfill the burrows to restore the levee to original condition.

View of multiple rodent holes on the levee slope.

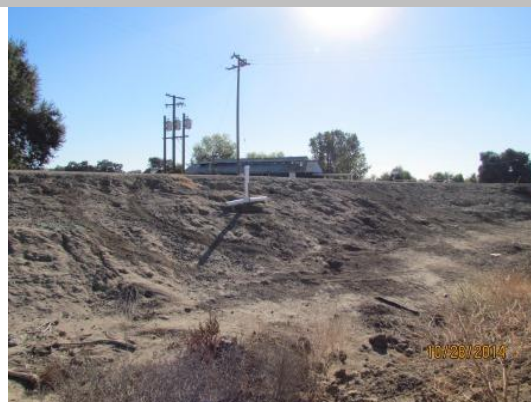
Photo 1 of 1 : SP_2018_RD2101_326_28_20180305_00015.jpg

LM Start	2.85	Rating **	M	Issue No.	28
LM End	2.85	Issue Type +	Ma	Location *	LS
Category	Earthen Levee			GPS Latitude/Longitude	
				Start	End
Item	Animal Control			37.640134 °	37.640134 °
				-121.230019 °	-121.230019 °
DWR ID	DWR_RD2101_01_s_2012_28				
Comment Code					
A3 : No rodents visible, but rodent burrows visible; need to backfill and compact or grout burrows.					
Inspector Comment					
Rodent holes were backfilled but some are still active. Continue to monitor the area and exterminate the rodents.

View of numerous rodent holes with bait stations present.

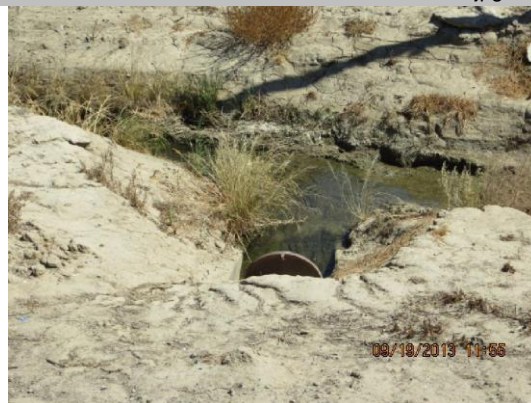
Photo 1 of 3 : UCIP_SP_2018_20875_35156.jpg

LM Start	2.87	Rating **	A/W	Issue No.	953
LM End	2.87	Issue Type +	Ma	Location *	
Category	Supplemental			GPS Latitude/Longitude	
				Start	End
Item	DWR UCIP LMA Responsibility			37.639924 °	37.639924 °
				-121.230005 °	-121.230005 °
DWR ID					
Comment Code					
Inspector Comment					
FS_ID:20875					
DS_ID:20707					
EP_NO: N/A					
Repair Type: No Action Needed					
Crossing Status: Found					
UCIP Comments:					
FIELD_STRUCT_DESC: 1 of 2: 24-inch corrugated metal drainage pipe					
through the levee, 12.5 feet below the crown. Concrete U-shaped					
headwalls on each end. Flap gate on the waterside (WS) end.					
[Additional Reference(s): DWR Levee Log, 1992. USACE San Joaquin					
O&M Manual 12, December 1968, (HLM 2.89)].					
FS Date: 9/19/2013

Flapgate on WS toe at concrete headwall.

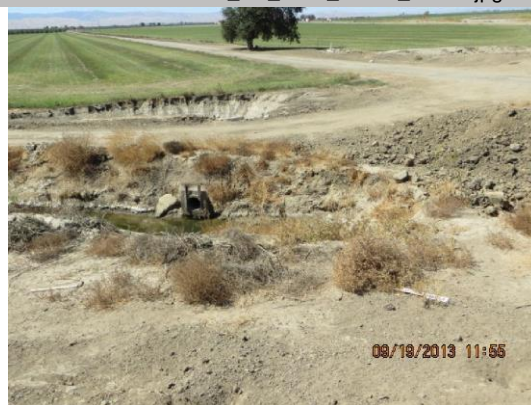
Photo 2 of 3 : UCIP_SP_2018_20875_35155.jpg

Inlet on LS toe with concrete headwall.

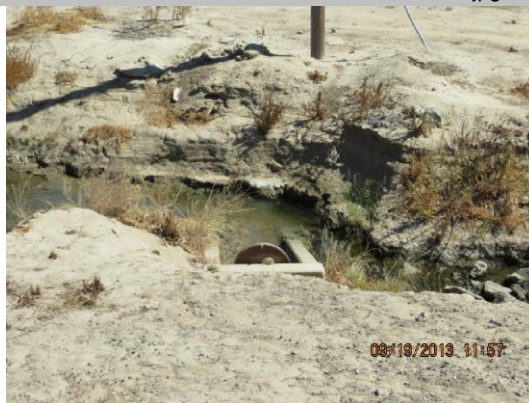
Photo 2 of 3 : UCIP_SP_2018_20876_35158.jpg

LM Start	2.87	Rating **	A/W	Issue No.	954 (cont)	
LM End	2.87	Issue Type +	Ma	Location *		
Category	Supplemental			GPS Latitude/Longitude		
				Start	End	
Item	DWR UCIP LMA Responsibility			37.639884 °	37.639884 °	
				-121.230008 °	-121.230008 °	
DWR ID						
Comment Code						
Inspector Comment						
FS_ID:20876						
DS_ID:20709						
EP_NO: N/A						
Repair Type: No Action Needed						
Crossing Status: Found						
UCIP Comments:						
FIELD_STRUCT_DESC: 2 of 2: 24-inch drainage pipe of an unknown material through the levee, 12.5 feet below the crown. Concrete U-shaped headwalls on each end. Flap gate on the waterside (WS) end. [Additional Reference(s): DWR Levee Log, 1992. USACE San Joaquin O&M Manual 12, December 1968, (HLM 2.89)].						
FS Date: 9/19/2013

Concrete U-shaped headwall on WS toe with flapgate.

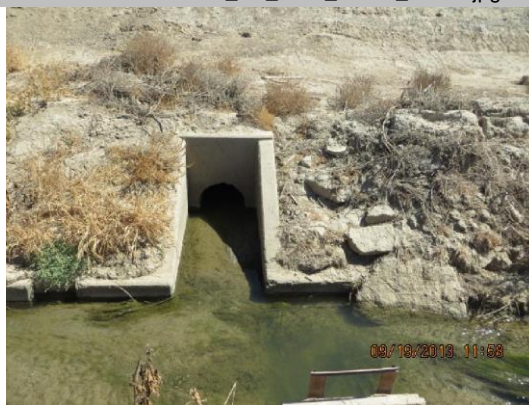
Photo 3 of 3 : UCIP_SP_2018_20876_35157.jpg

Concrete inlet on LS toe at canal.

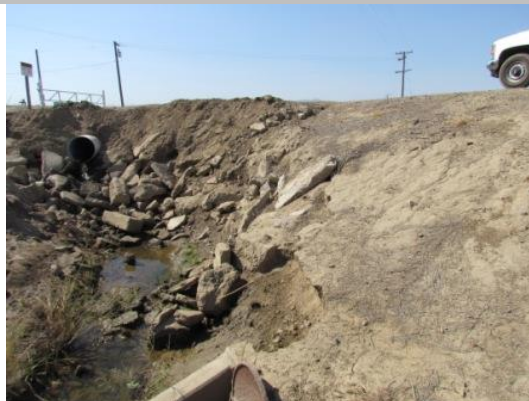
Photo 1 of 2 : SP_2018_RD2101_326_29_20180305_00016.jpg

LM Start	2.87	Rating **	M	Issue No.	29
LM End	2.87	Issue Type +	Ma	Location *	WS
Category	Earthen Levee			GPS Latitude/Longitude	
				Start	End
Item	Erosion / Bank Caving			37.639852 °	37.639852 °
				-121.229980 °	-121.229980 °
DWR ID	DWR_RD2101_01_s_2012_29				
Comment Code					
E1 : Note and monitor erosion site.					
Inspector Comment

View of repaired site, but it appears that erosion is still occurring.
09/25/2012

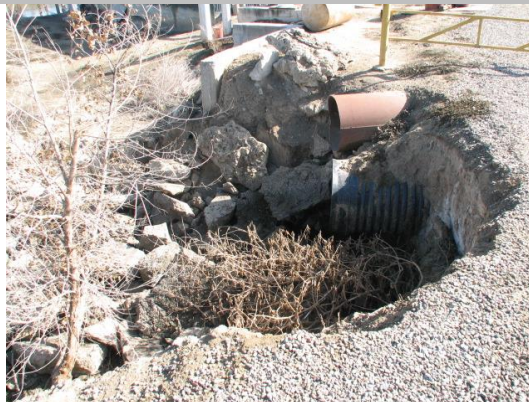
Photo 2 of 2 : SP_2018_RD2101_326_29_20180305_00017.jpg

Levee slope is being eroded at this location. Repair needed to preserve access road.

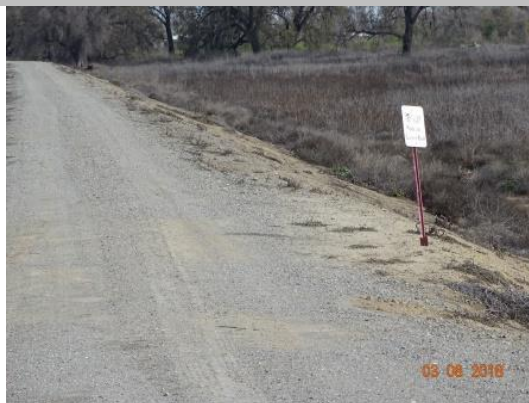
Photo 1 of 1 : SP_2018_RD2101_327_1_20180308_00001.jpg

LM Start	0.01	Rating **	A	Issue No.	1	
LM End	0.01	Issue Type +	Ma	Location *	WS	
Category	Earthen Levee			GPS Latitude/Longitude		
				Start		End
Item	Vegetation			37.659866 °		37.659866 °
				-121.243509 °		-121.243509 °
DWR ID	DWR_RD2101_02_s_2018_1					
Comment Code						
V1 : Control annual grass and weeds on the levee slopes and easements.						
Inspector Comment						
Acceptable vegetation control.

View of the acceptable vegetation control on the levee slope.
